**POHAKEA WATERSHED / MA ALAEA BAY  
MAUI COUNTY, HAWAII  
STORMWATER MANAGEMENT PLAN**

November 16, 2018

**Maui Environmental Consulting, LLC  
PO Box 790568  
Paia, HI 96779 • 808-866-6919**

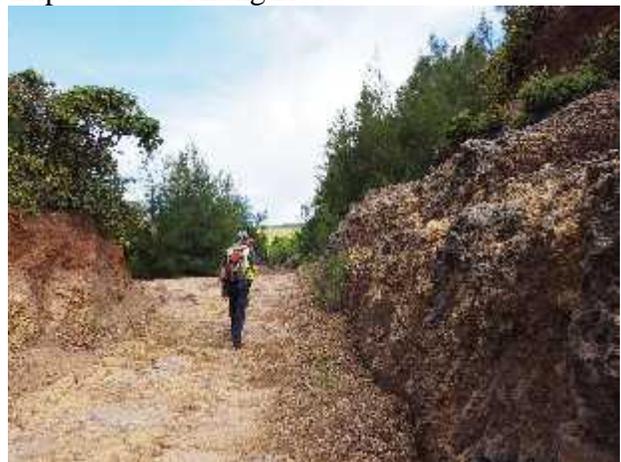
Exposed Soil Along Road

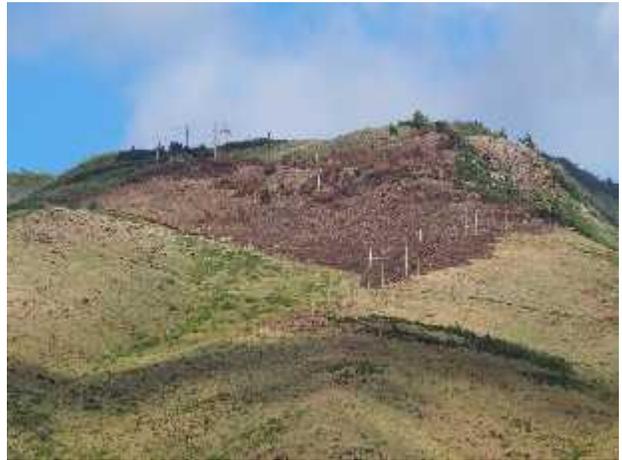
Downed Communications Lines

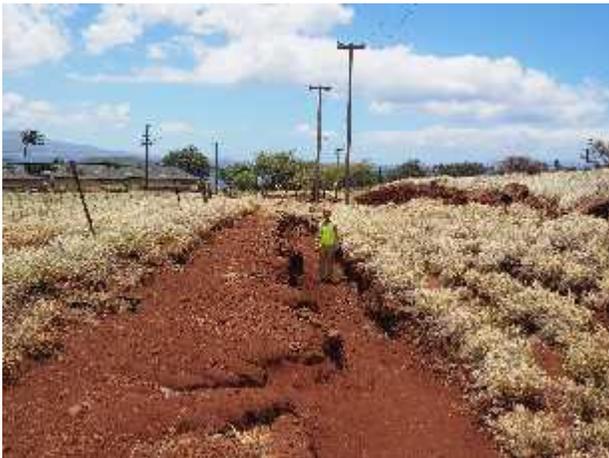
Fire Lines Associated with Powerlines

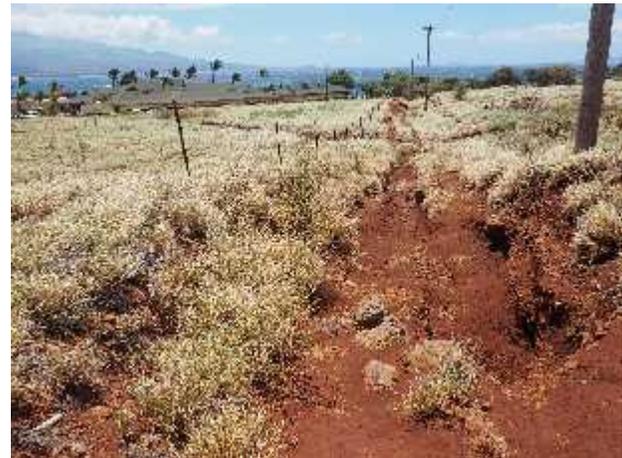
Distribution Lines and Failed Roads

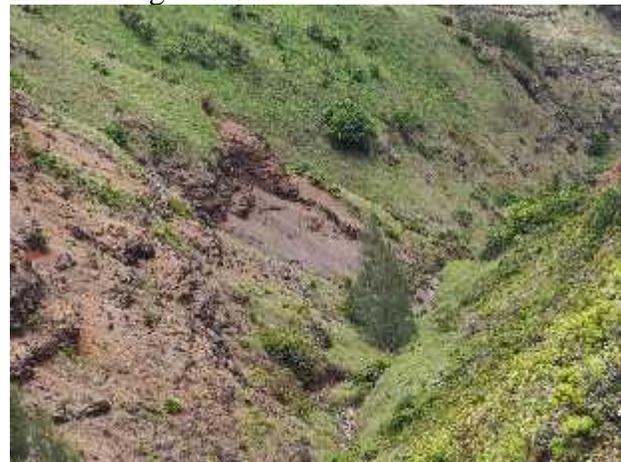
**Soil Loss and Remaining Vegetation**

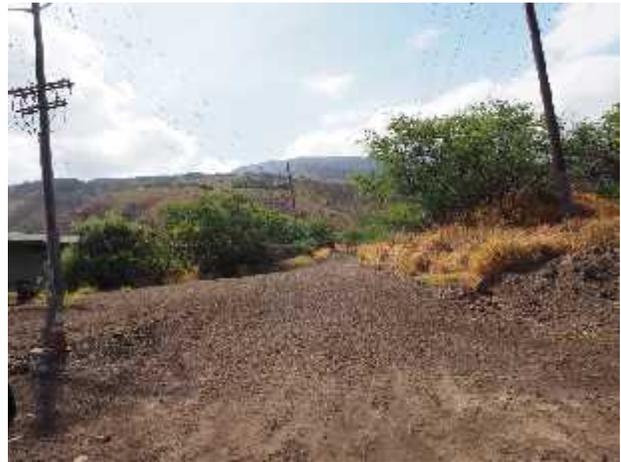
Gravel Roads with Mud and Erosion

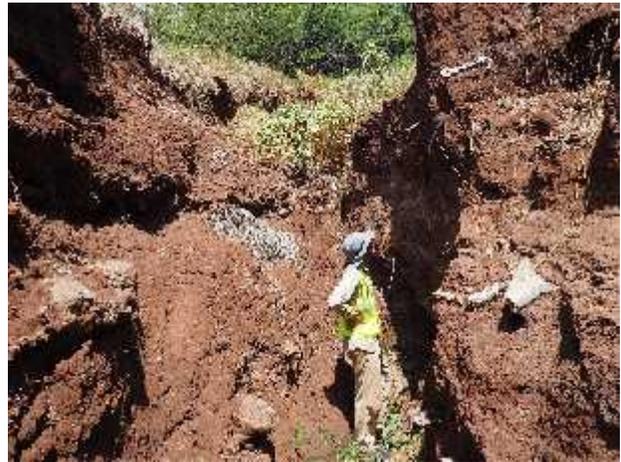
Head Cutting

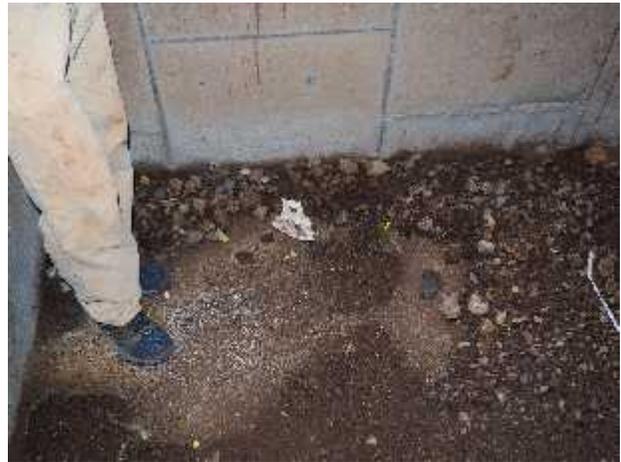
Sediment in Culverts

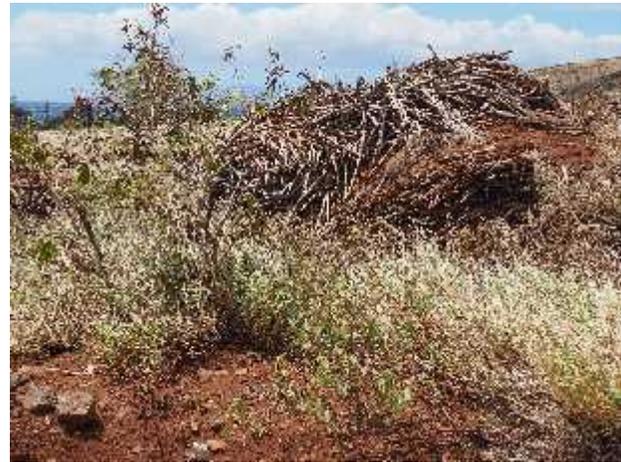
Highly Eroded Stream Channel

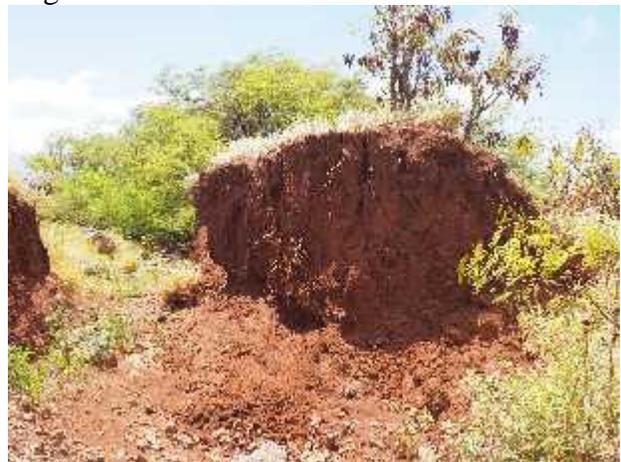
Evidence of Severe Erosion

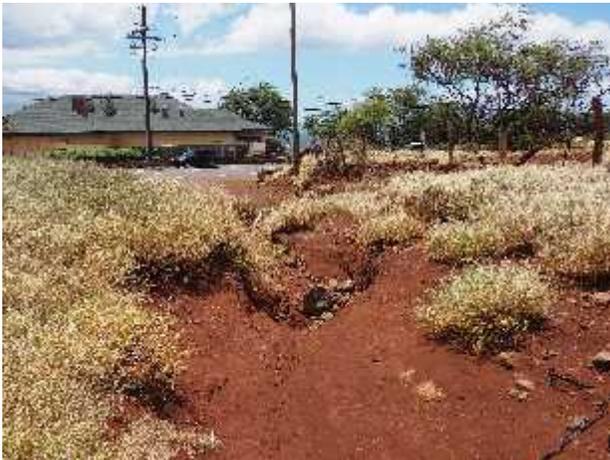
Channelization and Erosion

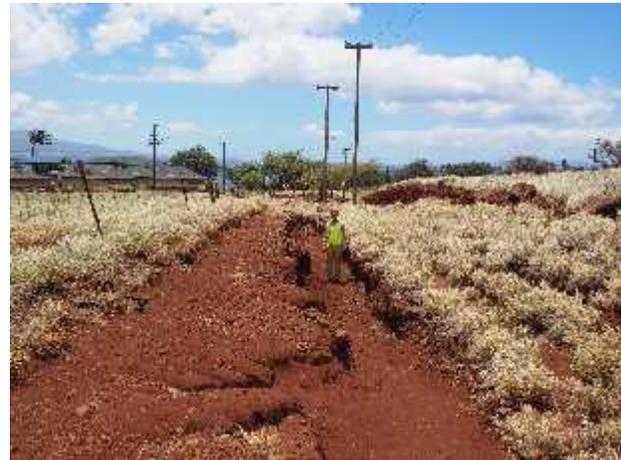
Failed Road with Channelization and Erosion

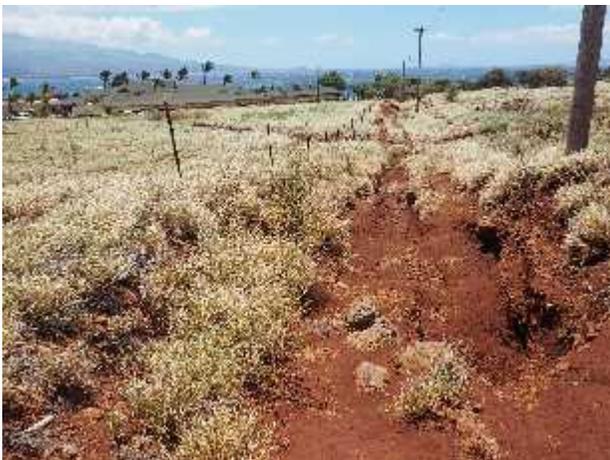
Failed Road with Channelization and Erosion

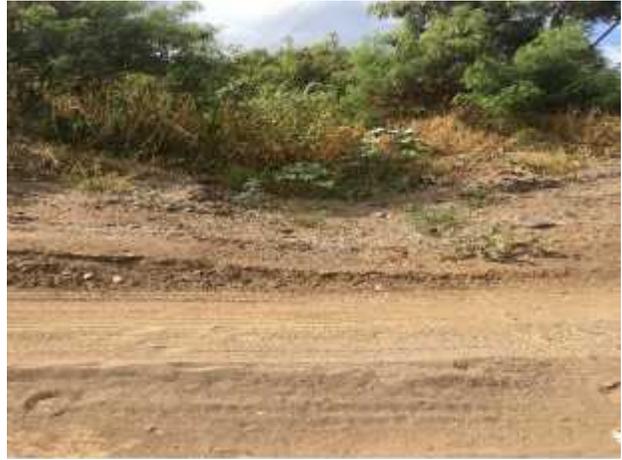
Road Crossing Pohakea Lacking BMPs

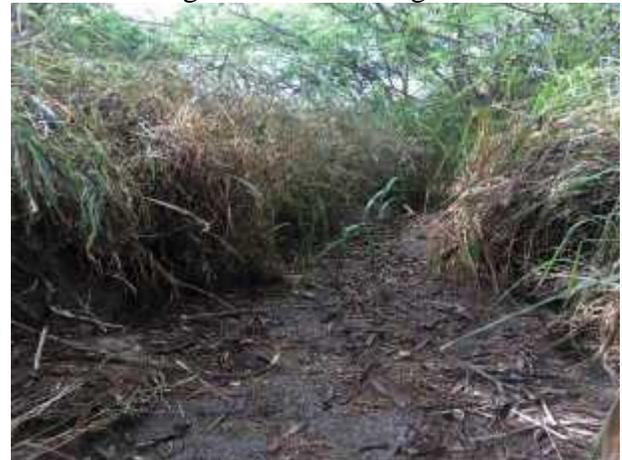
Bank Cutting within Pohakea

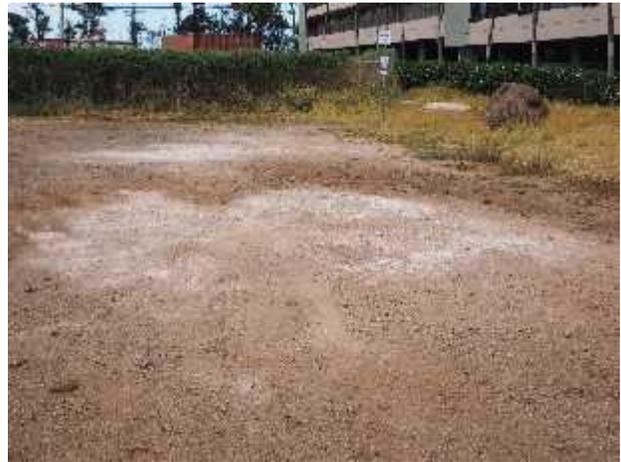
Dirt Lots with No BMPs in Place

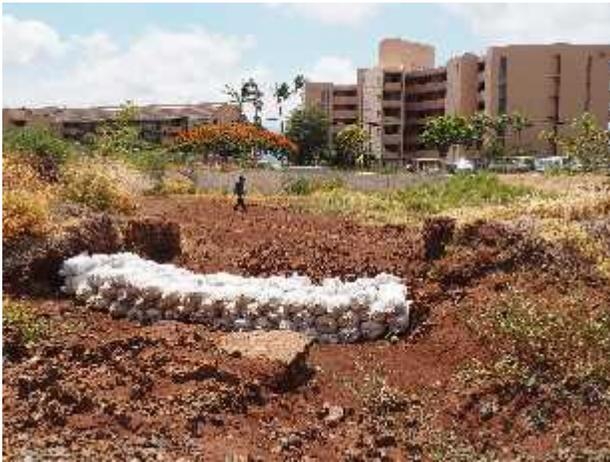
There is a failed detention basin mauka of Hau oli Street and the Maui Island Sands Resort. Constructed following the major storms in September and December of 2016, this detention basin receives the flows from Kanaio Stream as well as several other unnamed streams representing a significant concentration point of stormwater flow from the landscape within the project area (Discharge Locations Map). Based on the observed failure, it is assumed the basin's size and construction are inadequate to handle the substantial flows it receives. This is evidenced by extensive head cutting and channel incision above the basin, and a breached control structure that divides the basin. This structure is a compacted earth and gravel berm that was intended to temporarily detain stormwater, and gradually release it through PVC stand pipes directed into the lower portion of the basin. The breach occurred at the center of this berm, directly in line with the point at which the stream enters the basin, indicating a high flow stream event which punched through the control structure carrying gravel and sediment material under Hau oli Street, down a concrete lined channel, and into the ocean between Maui Island Sands Resort and the Ma alaea Banyans. This basin, its associated head cut, and the failed control structure, all represent sediment sources in the flow path waiting for the next storm to be transported to the ocean each time the stream flows.

Sand Bags at Failed Control Structure

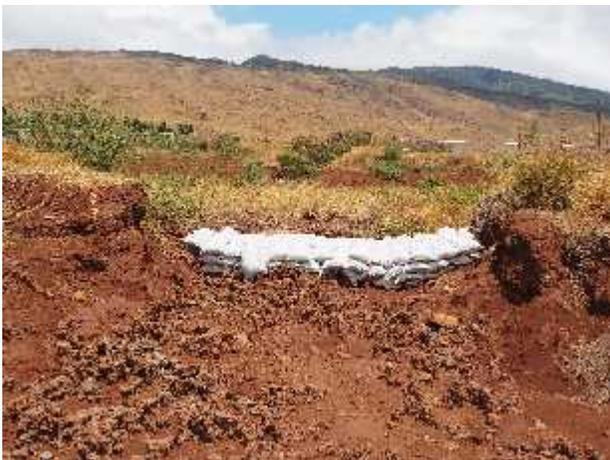
Failed Control Structure
