**POHAKEA WATERSHED / MA ALAEA BAY  
MAUI COUNTY, HAWAII  
STORMWATER MANAGEMENT PLAN**

November 16, 2018

**Maui Environmental Consulting, LLC  
PO Box 790568  
Paia, HI 96779 • 808-866-6919**

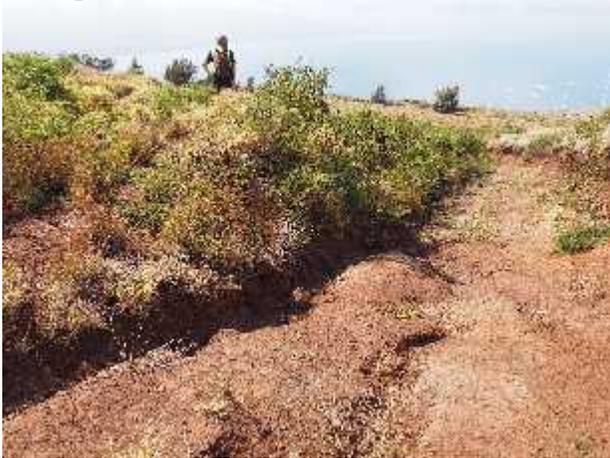
Road Channelization

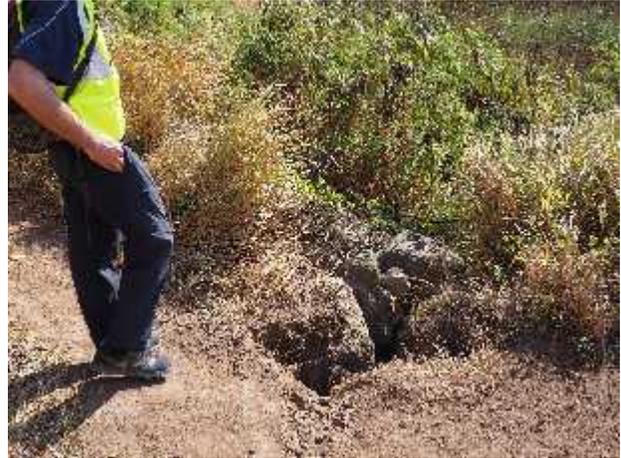
Erosion and Discharge from Road

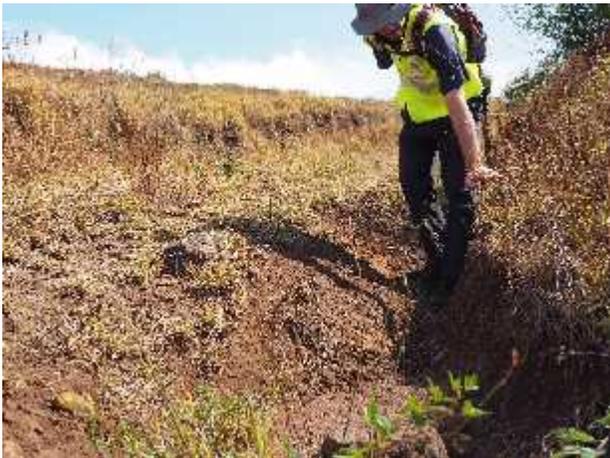
Road Channelization

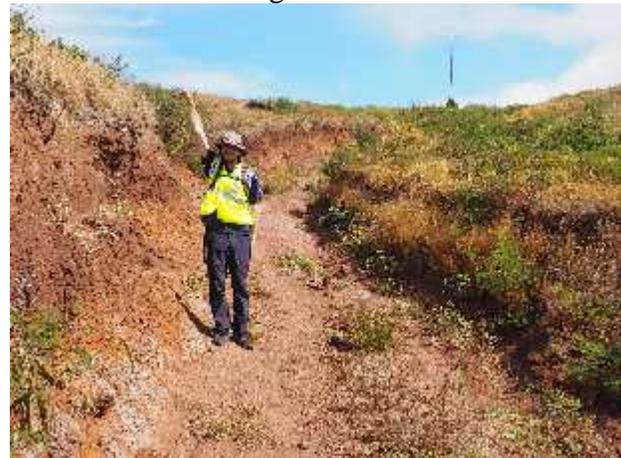
Exposed Soil Along Road

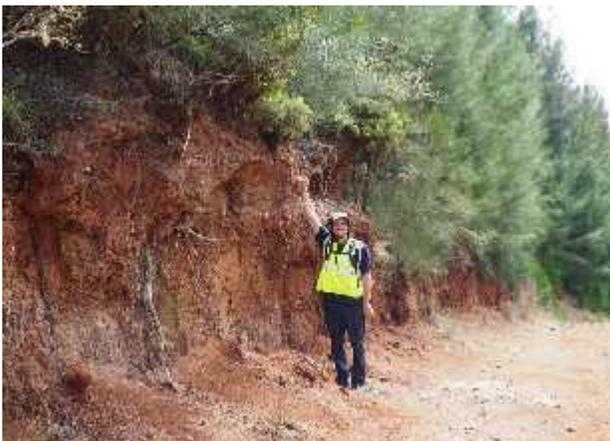
Exposed Soil Along Road

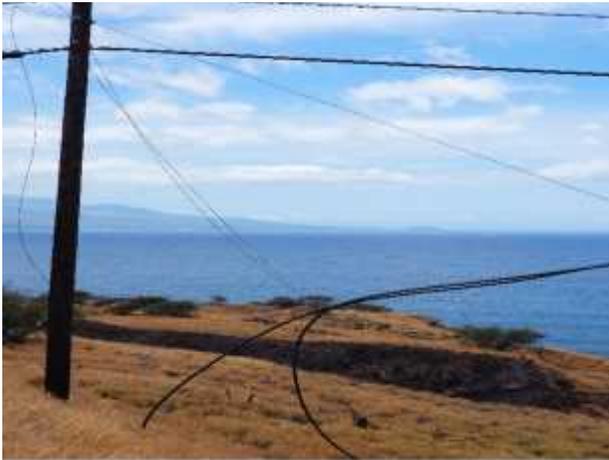
Downed Communications Lines

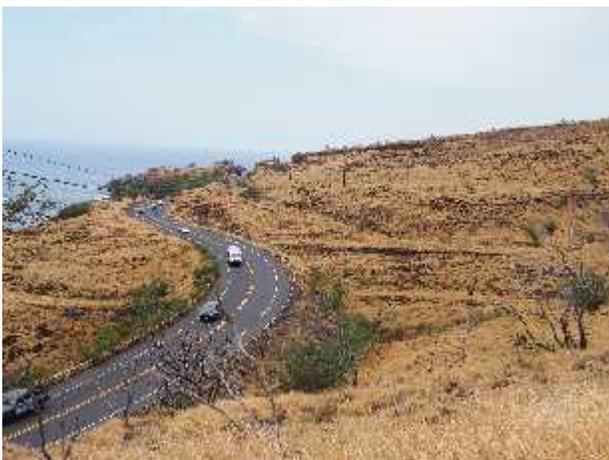
Transmission Lines along the Pali

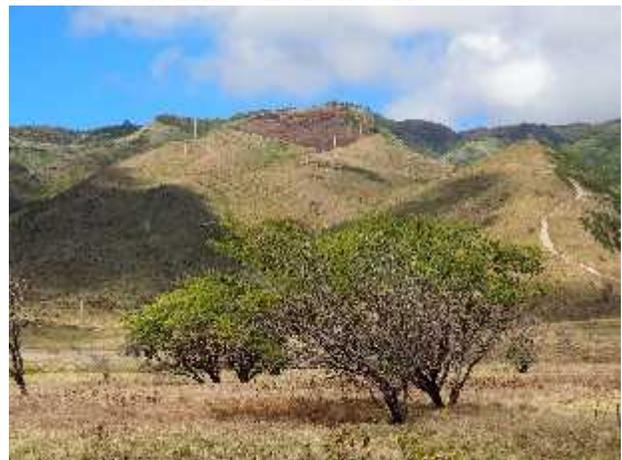
Transmission Corridor and Evidence of Fire

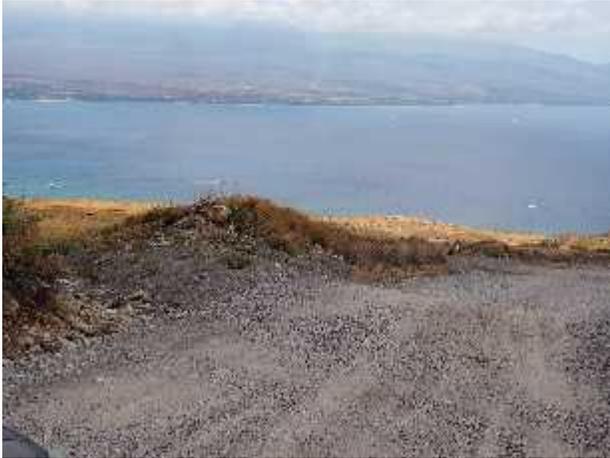
Water Bars and Kickouts

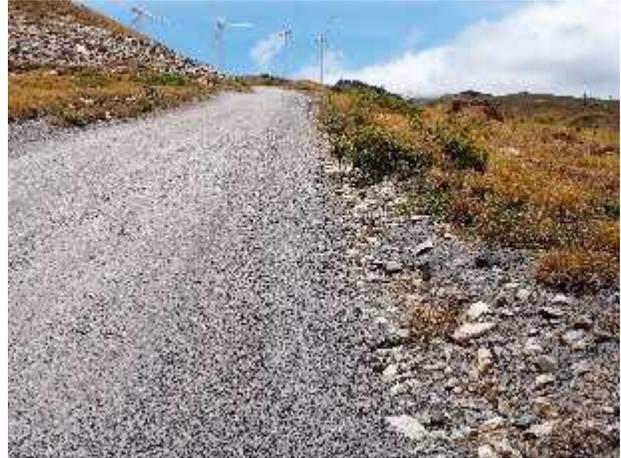
Well Maintained Road with Swale

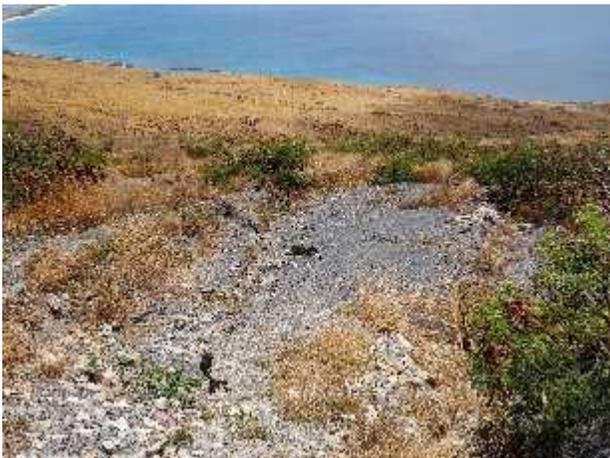
Gravel Loss at Kickouts

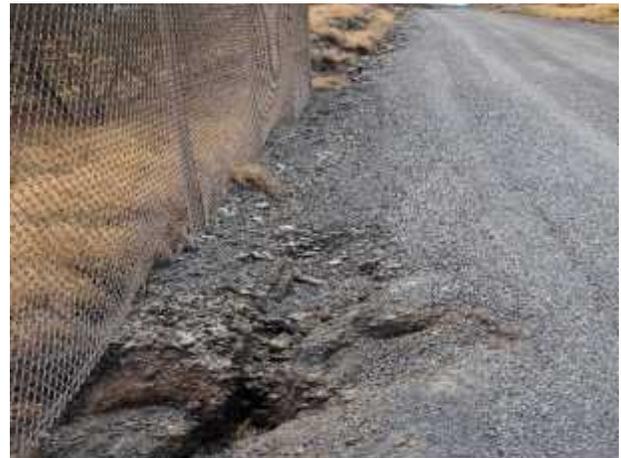
Erosion

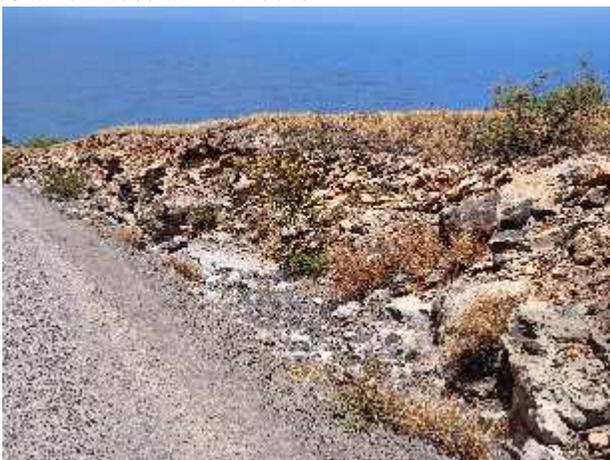
Channelization and Gravel Loss in Swale  
Section 1 Conservation Lands

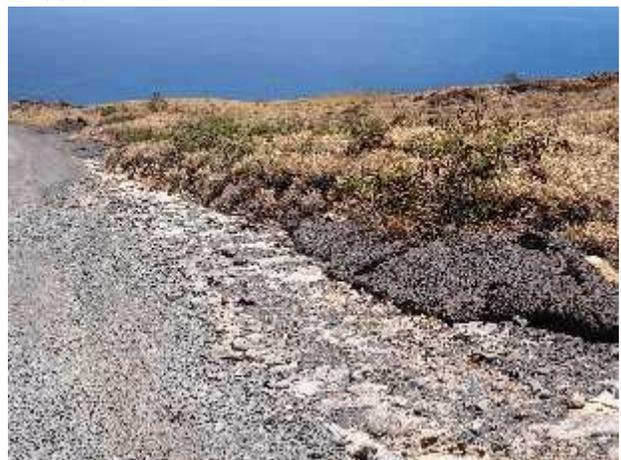
Gravel Loss in Swale

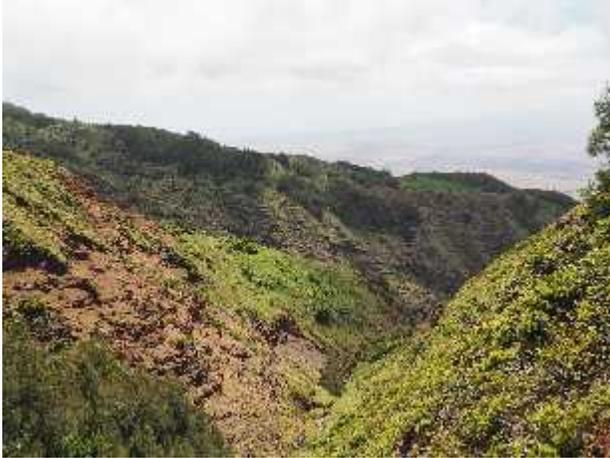
**Loss of Vegetation**

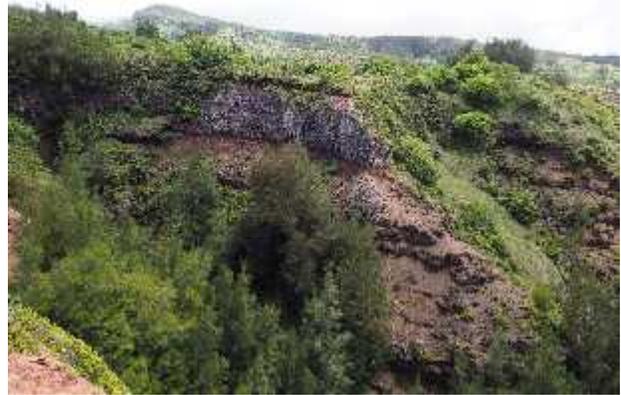
**Loss of Vegetation**

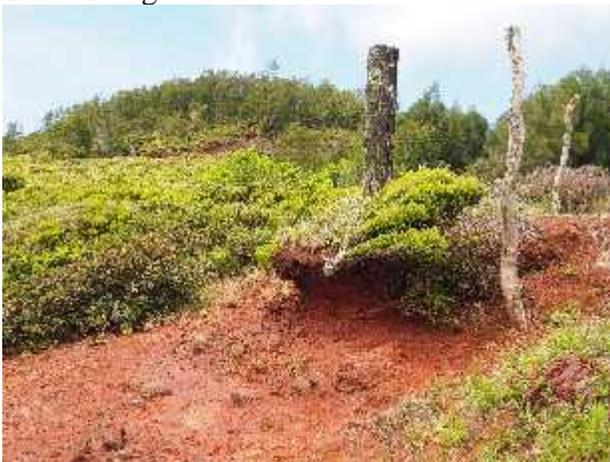
**Soil Loss and Remaining Vegetation**

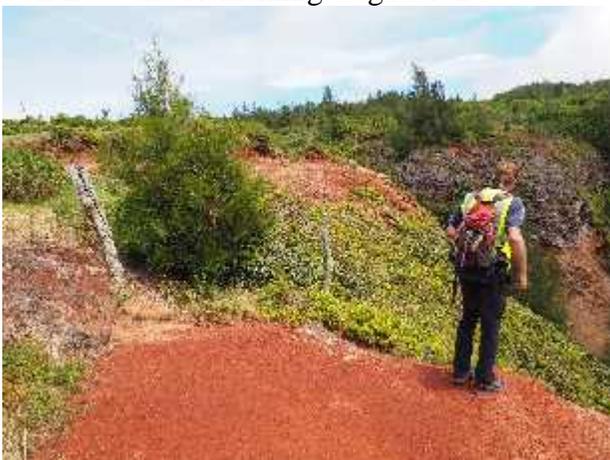
**Bare Ground Areas  
Section 2 Mid-Level Agricultural Lands  
Agricultural Roads and Fire Breaks:**

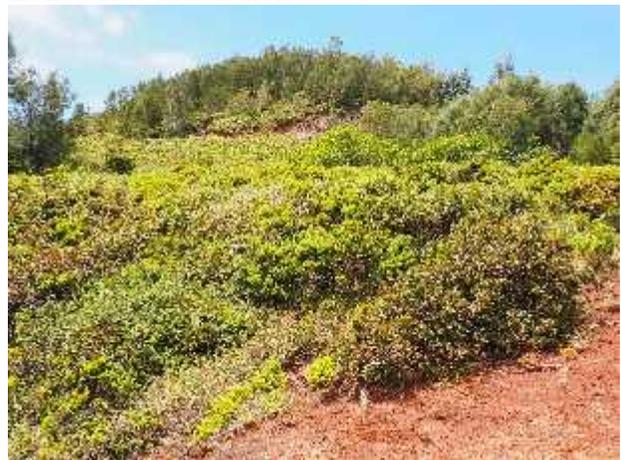
**Bare Ground and Native Vegetation**

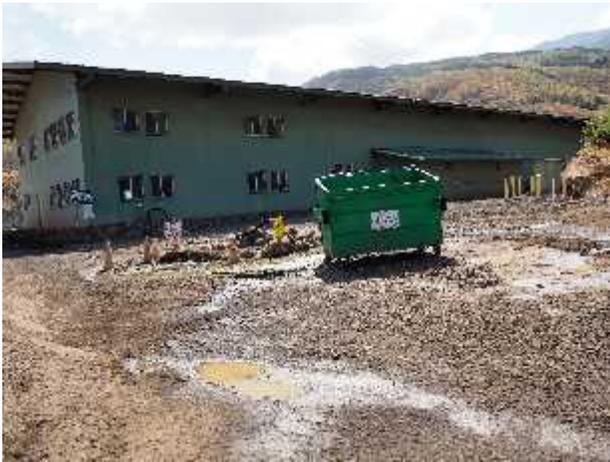
Gravel Roads with Mud and Erosion

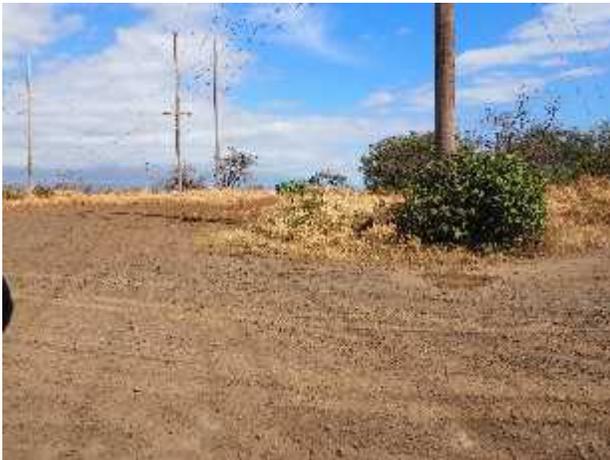
Gravel Roads Near Ditches

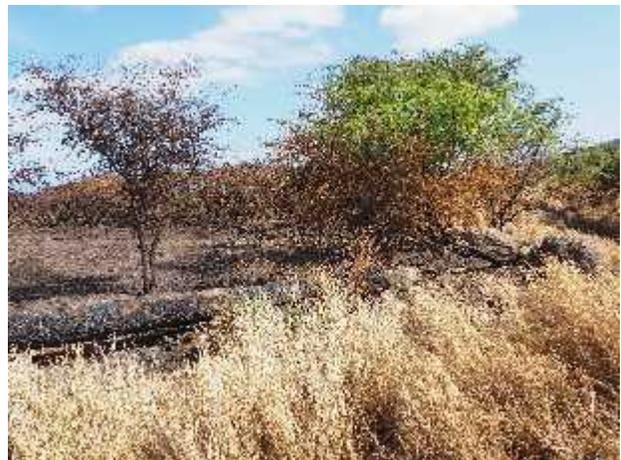
Evidence of Fire Near Entrance

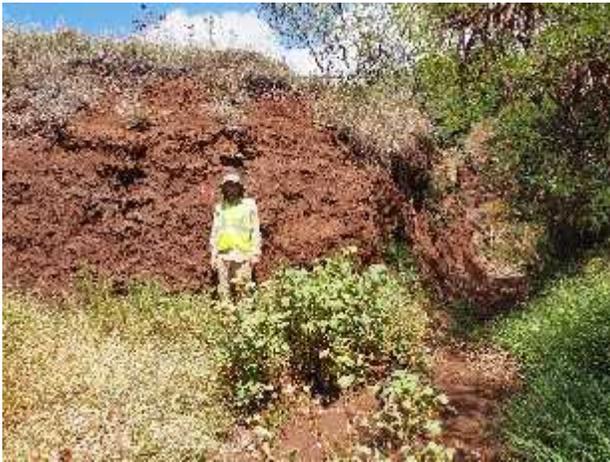
Head Cutting

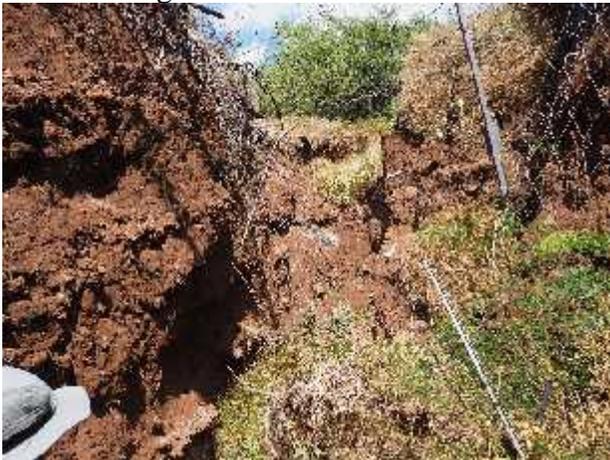
Channelization

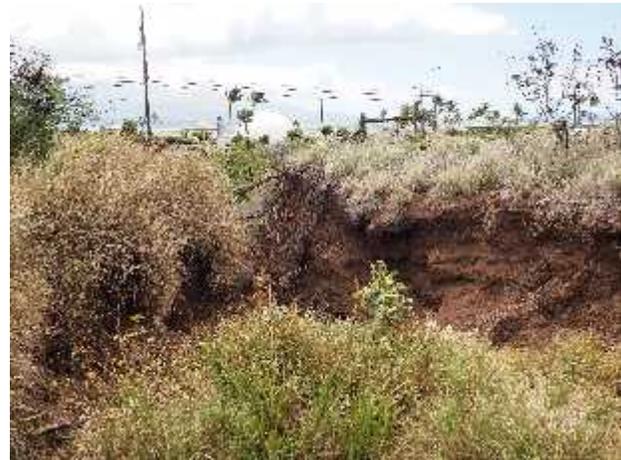
Head Cutting

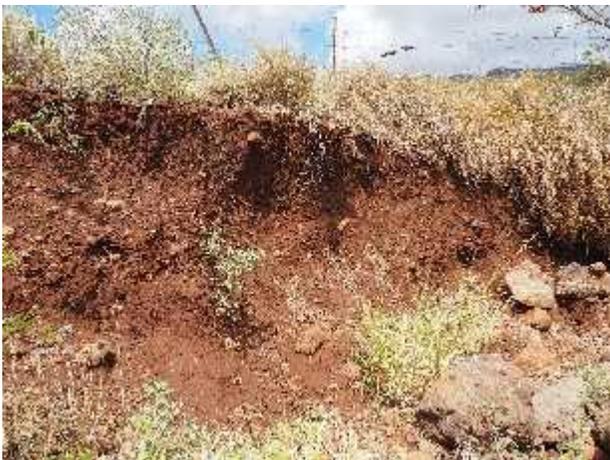
Head Cutting  
Section 2 Mid-Level Agricultural Lands  
Sediment and Vegetation in Culverts:

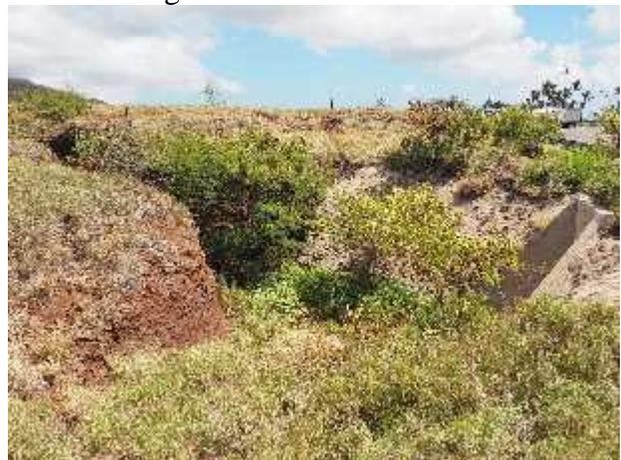
Culvert Backwall and Head Cutting

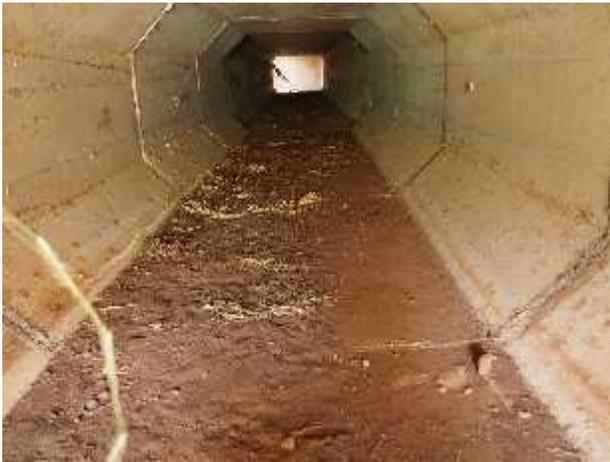
Sediment in Culverts

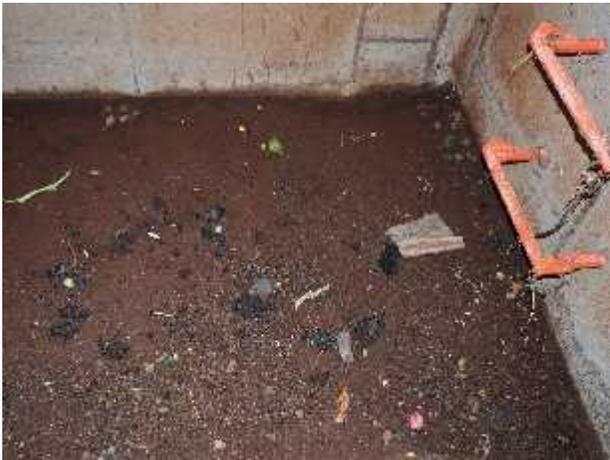
Sediment and Gravel in Culverts

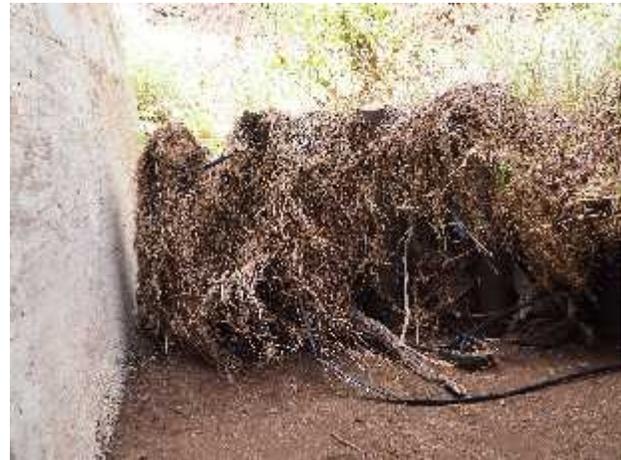
Vegetation at Entrance to Culvert

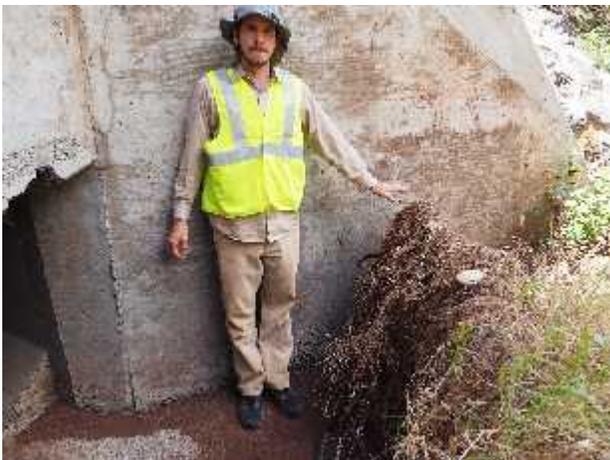
Extent of Vegetation at Entrance to Culvert  
Section 2 Mid-Level Agricultural Lands  
Waihe e Makai Ditch:

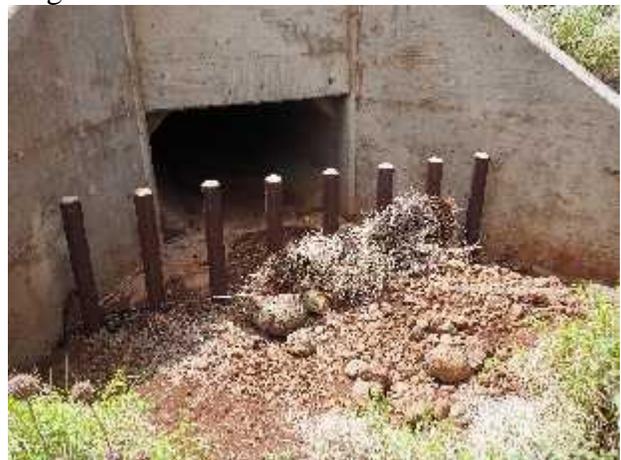
Sediment and Gravel at Culvert Entrance

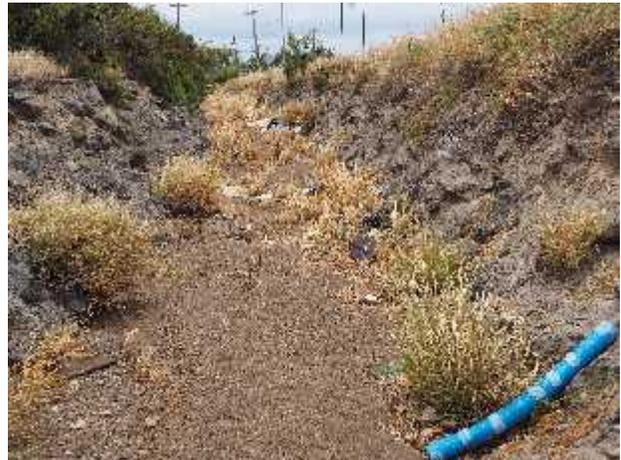
Rubbish in Ditch

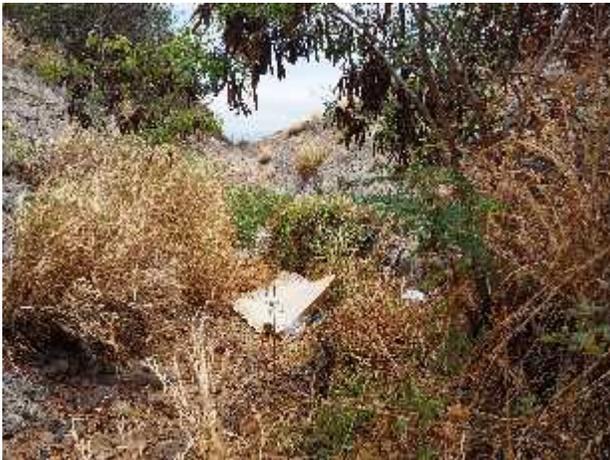
Vegetation and Rubbish in Ditch

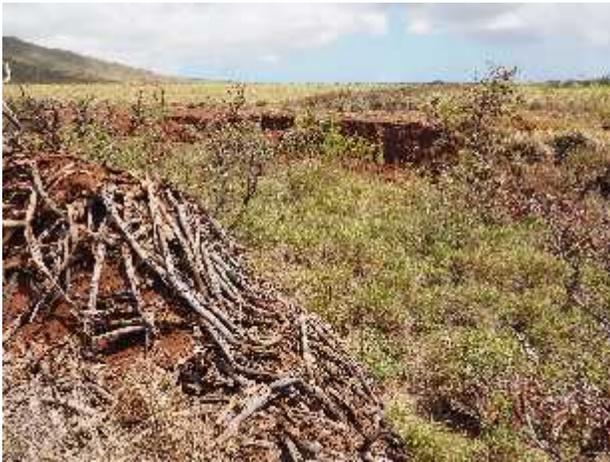
Sugar Cane Push Piles Near Gulch

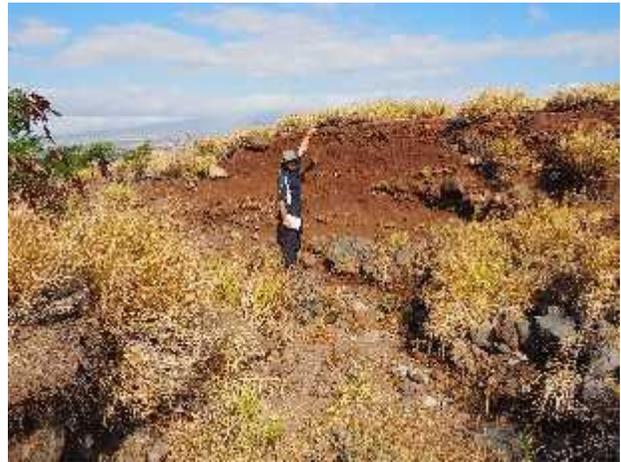
Extent of Erosion

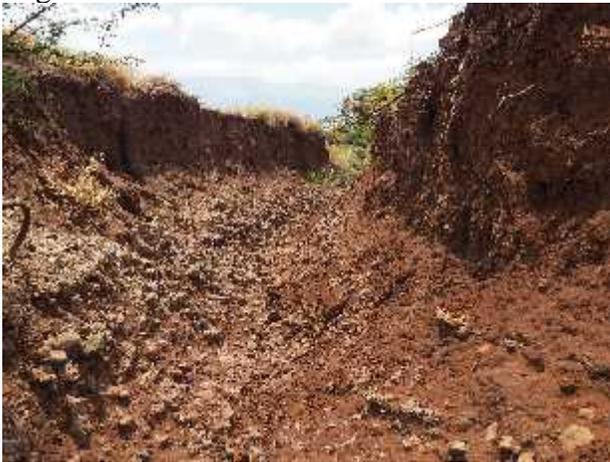
Highly Eroded Stream Channel

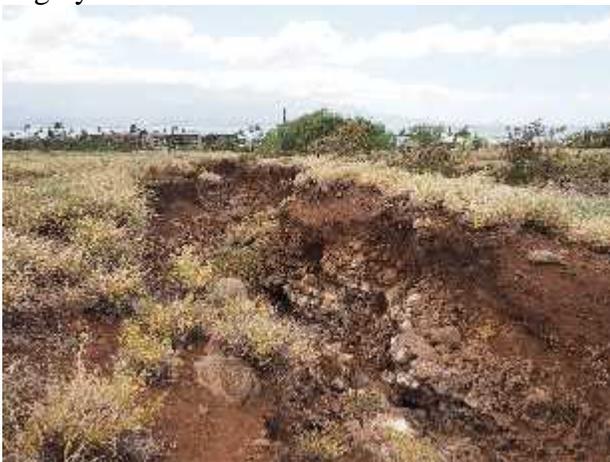
Highly Eroded Stream Channel  
Section 2 Mid-Level Agricultural Lands

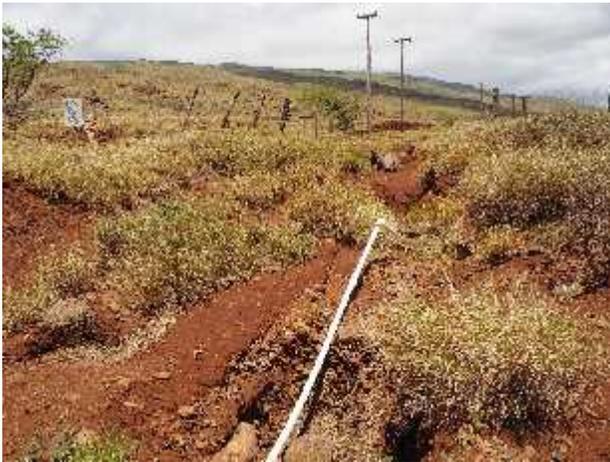
Channelization and Erosion

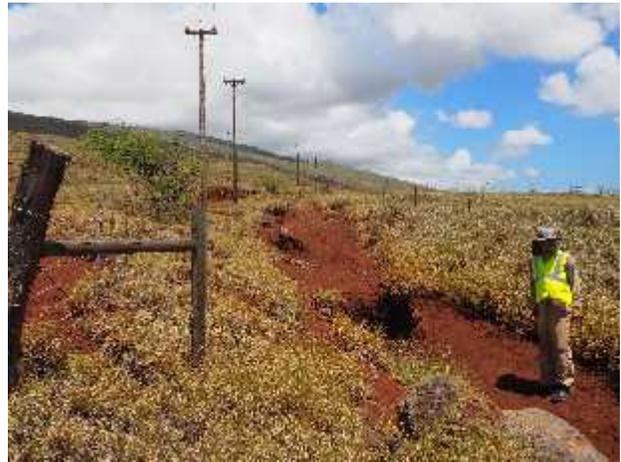
Channelization and Erosion

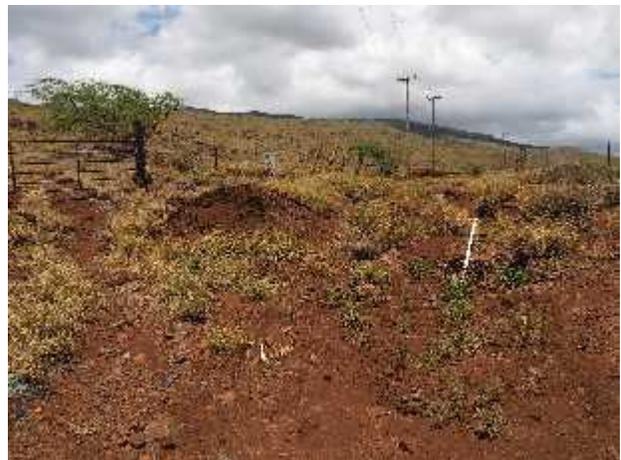
Gravel Piles Near Highway

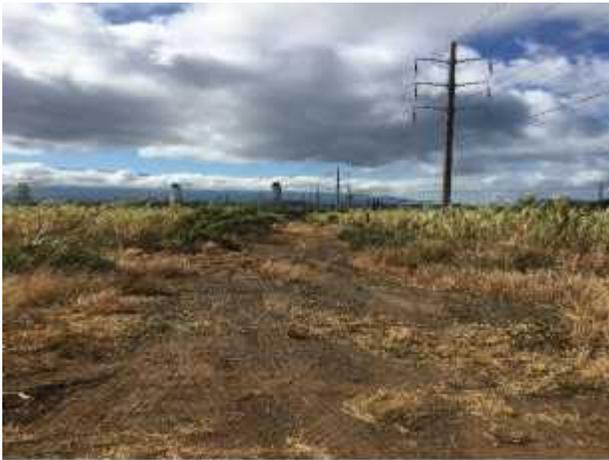
Transmission Corridor Next to Pohakea

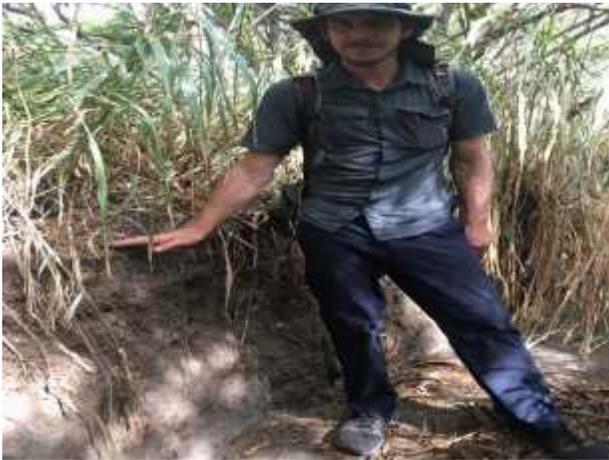
Bank Cutting within Pohakea

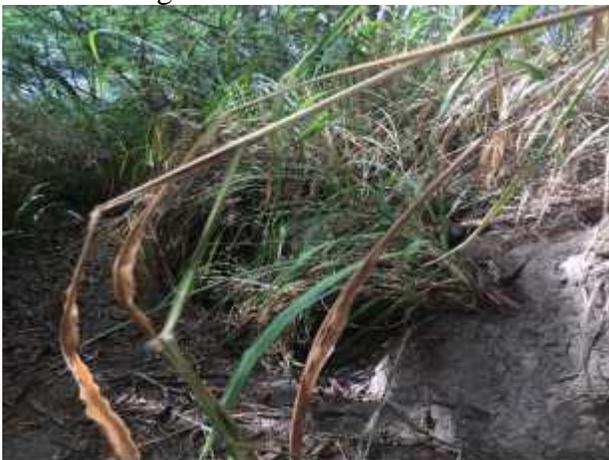
Exposed Stream Banks within Pohakea  
Section 3 Commercial and Urban Lands  
Water Quality Monitoring:

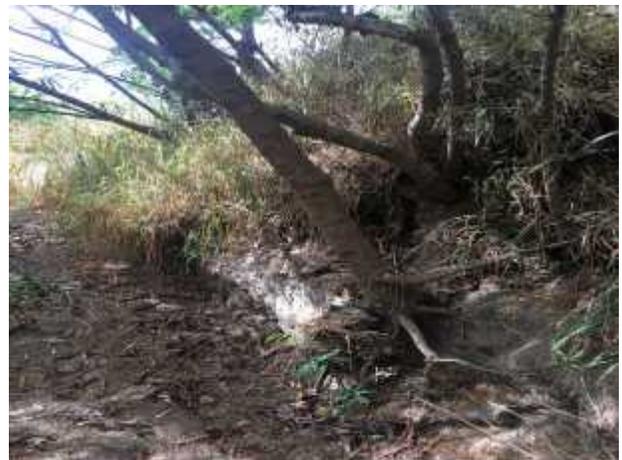
Wrack Lines and Eroded Bank within Pohakea

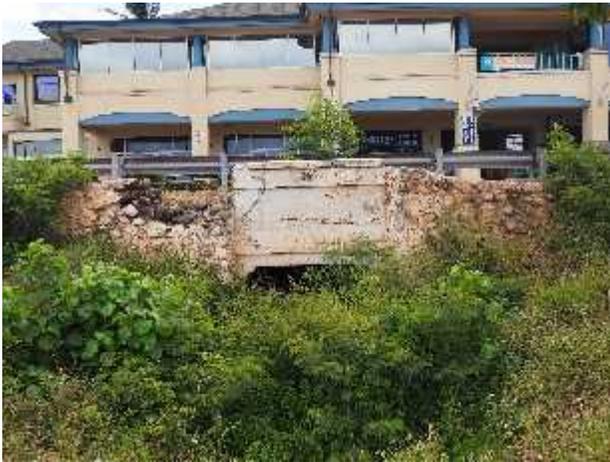
Ma alaea Triangle Outfall

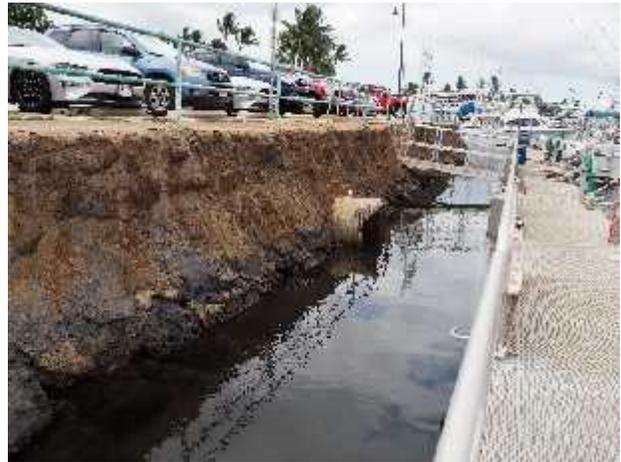
Culverts Discharging into Harbor

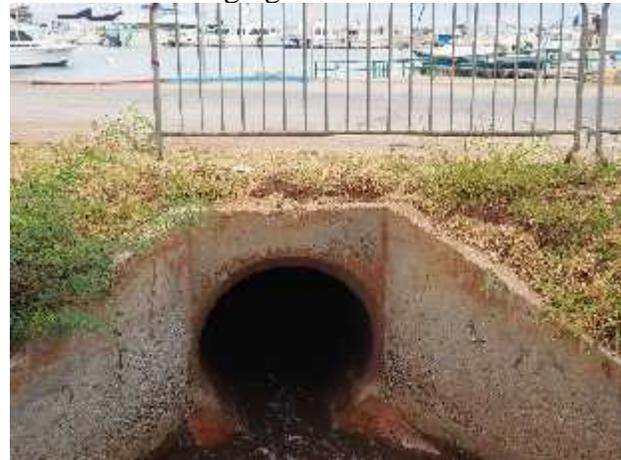
Culverts Discharging into Harbor

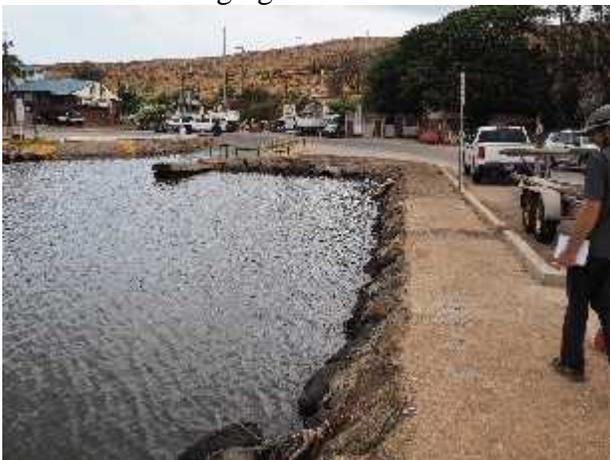
Culvert Outfall to Harbor  
Section 3 Commercial and Urban Lands  
Ma alaea Harbor Dirt Lots:

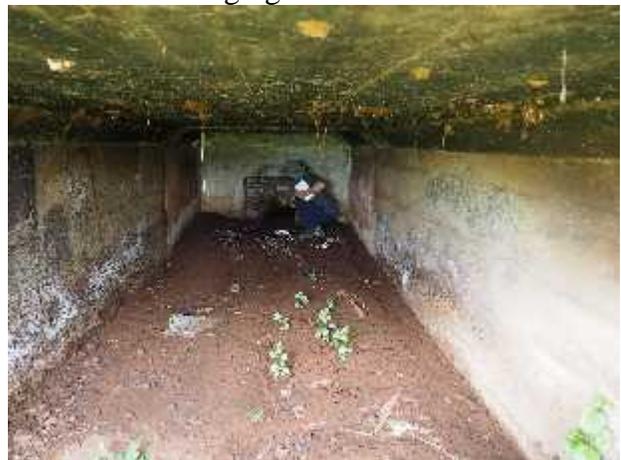
Substantial Sediment Deposition in Culvert

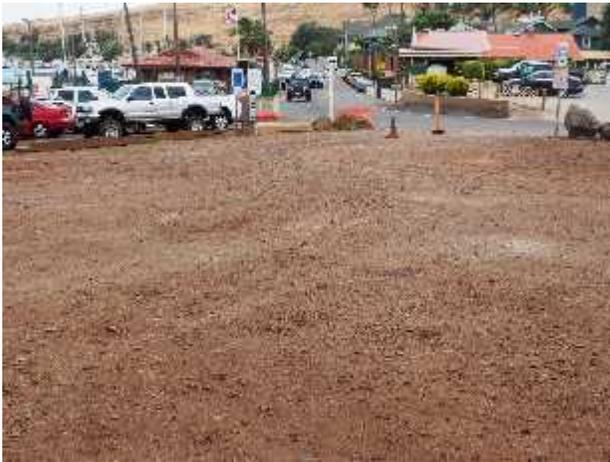
Dirt Lots with No BMPs in Place

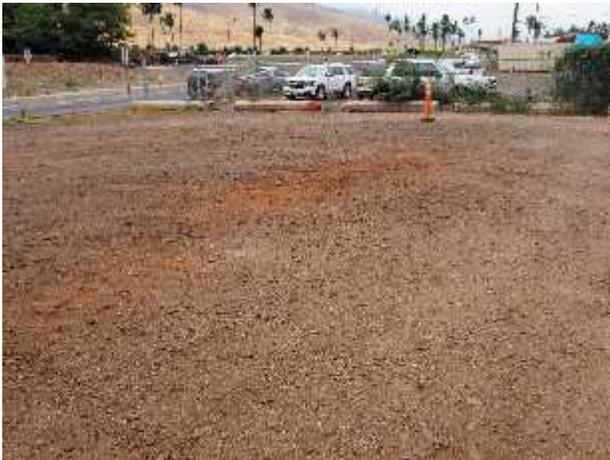
Dirt Lots with No BMPs in Place

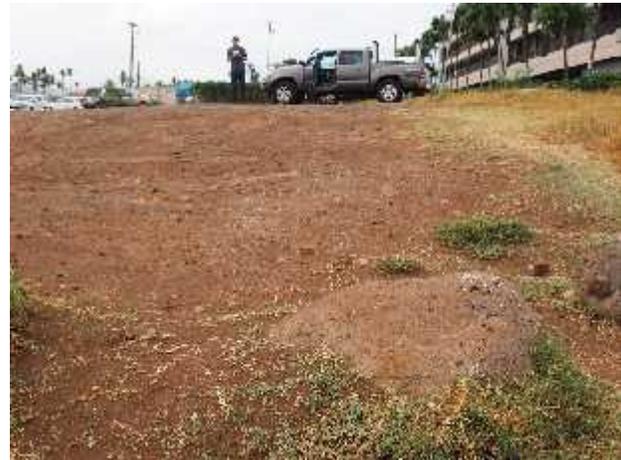
Dirt Lots with No BMPs in Place

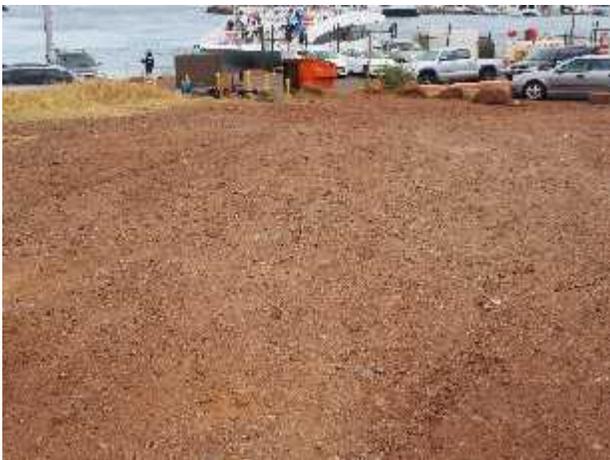
Dirt Lots with No BMPs in Place Next to Harbor  
Section 3 Commercial and Urban Lands  
Failed Detention Basin:

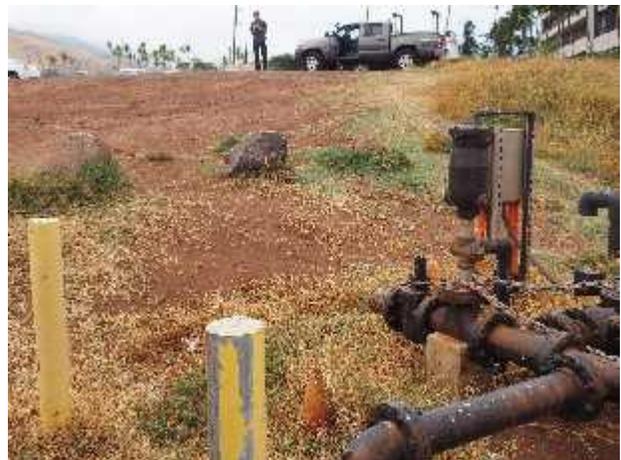
Dirt Lots with No BMPs in Place

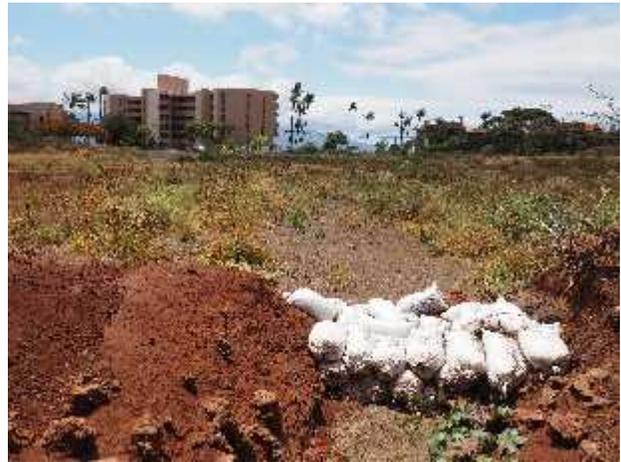
Sand Bags at Channel Outfall to Detention Basin

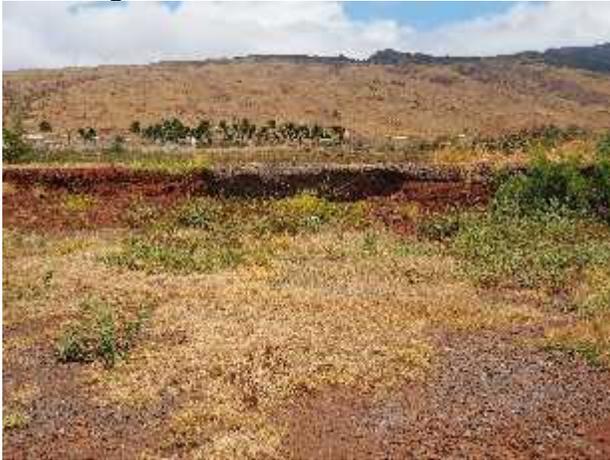
Eroded Sidewalls

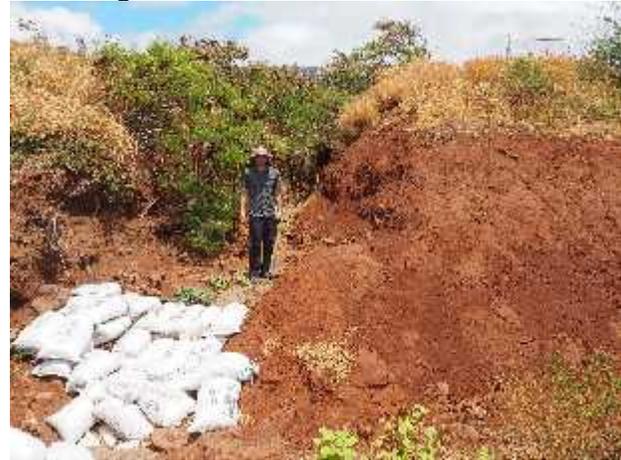
Sand Bags at Channel Outfall to Detention Basin

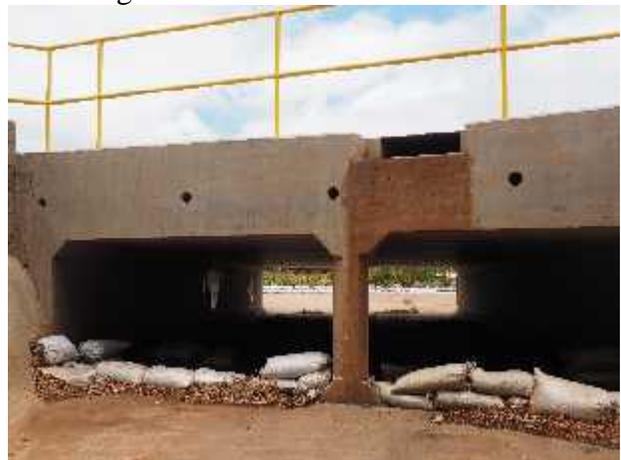
Sand Bags Under Hau oli Street
